DEPARTMENT OF TRANSPORTATION**DIVISION OF ENGINEERING SERVICES**

Contract #: 04-0120F4Cty: SF/ALA Rte: 80 PM: 13.2/13.9File #: 1.28**WELDING INSPECTION REPORT****Resident Engineer:** Casey, William**Address:** 333 Burma Road**City:** Oakland, CA 94607**Report No:** WIR-026637**Date Inspected:** 03-Nov-2011**Project Name:** SAS Superstructure**OSM Arrival Time:** 700**Prime Contractor:** American Bridge/Fluor Enterprises, a JV**OSM Departure Time:** 1730**Contractor:** American Bridge/Fluor Enterprises, a JV**Location:** Job Site

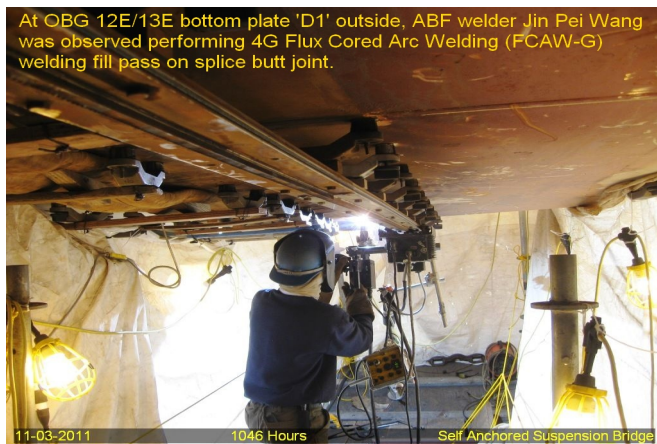
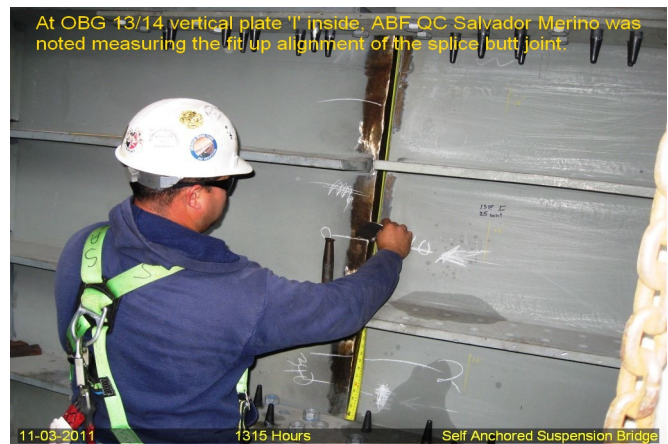
QA randomly observed ABF/JV qualified welder Jin Pei Wang continuing to perform CJP groove (splice) welding fill pass on Orthotropic Box Girder (OBG) 12E/13E bottom plate 'D1'. The welder was observed welding in the 4G (overhead) position utilizing a dual shield Flux Cored Arc Welding (FCAW-G) with E71T-1M, 1/16" diameter wire electrode and implementing Caltrans approved Welding Procedure Specification (WPS)

ABF-WPS-D15-3110-4. The welder was using a track mounted welder holder assembly that was remotely controlled. The joint being welded has the backing bar gouged using the Esab Plasma Arc machine and was ground smooth. The splice joint was preheated to greater than 200 degree Fahrenheit prior welding and the vicinity was properly protected from wind. During welding, ABF Quality Control (QC) Fred Von Hoff was noted monitoring the welding parameters of the welder. The parameter readings taken during welding were 275 amperes, 23.8 volts with travel speed of 190 mm per minute travel speed which were deemed acceptable to contract specifications. Prior welding, the welder was noted grinding off the porosity that was present on three locations that was due to shielding gas issue according to the welder. The porosity removal was verified by this QA and after it was cleared, the welder preheated back the plates to required temperature of more than 200°F and then resumed the overhead FCAW-G welding. During the shift, the welding observations for the location mentioned above was turned over to fellow QA Craig Hager and this QA went to OBG 13E/14E bottom and side plates and performed alignment verification of the butt joint fit up.
